Nooter/Eriksen
Aftermarket Services

LP Economizer Alterations November 2009 – Massachusetts

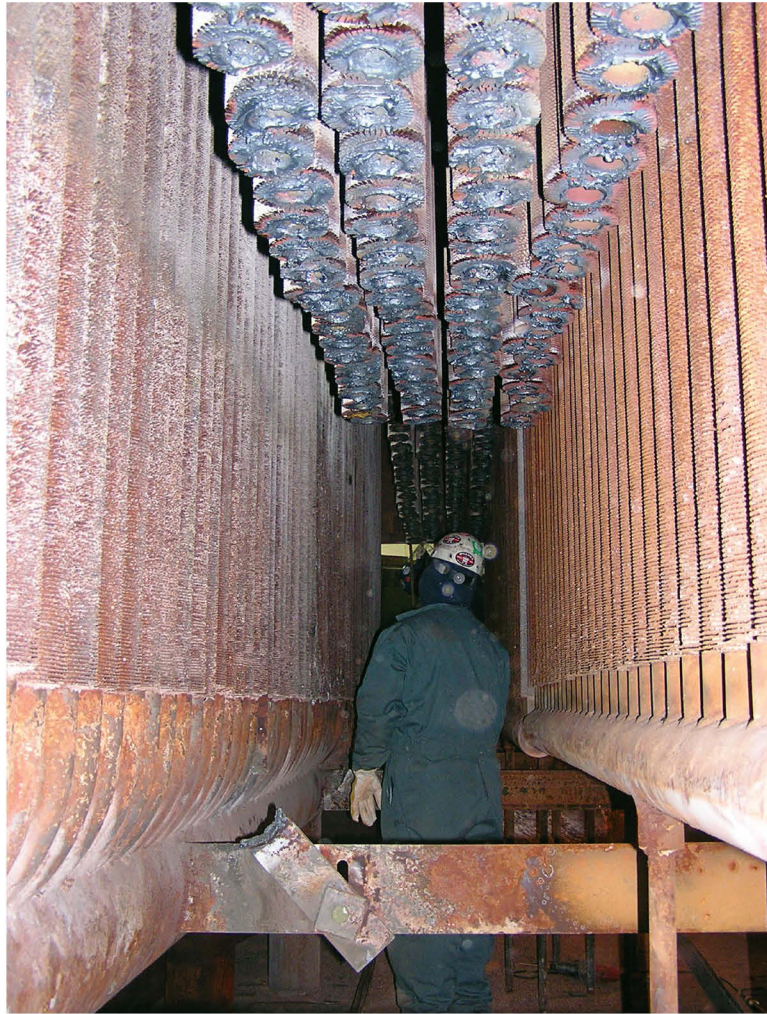
A power producer with a **Nooter/Eriksen** HRSG which had been operating for over 10 years had experienced unacceptable backpressure levels in their unit over the past few years. The backpressure increase was caused by fouling of the finned tubes, primarily in the LP Economizer coils in the “cold” end of the HRSG. These coils in some operating cases fall below the dew point temperature of certain compounds that condense out of the exhaust gas. The fouling in this case had

been found to primarily consist of ammonia bisulfate, formed when the sulfur in the exhaust is converted by the CO catalyst to SO₃ and combines with excess ammonia from the SCR system. Compounding this problem was the plant's change from their original design for base-load operation to frequent cycling and partial load cases where the LP Economizer coils operate more frequently below the acid dew point. Cleaning of the coils was only marginally effective due to tight coil spacing driven by original EPC design specifications.

Nooter/Eriksen had previously assisted the plant with the backpressure issues by evaluating and modifying the HRSG casing for a higher allowable backpressure. As backpressure continued to rise, it reached a point where the gas turbine could not reach base-load operation in the cold winter months. A unique solution was proposed to remove four tube rows from the LP Economizer to immediately reduce backpressure and also create a new cleaning lane to further reduce backpressure utilizing CO₂ blasting.
