Nooter/Eriksen
Aftermarket Services

Vibration Support Modifications – April 2010 – Texas

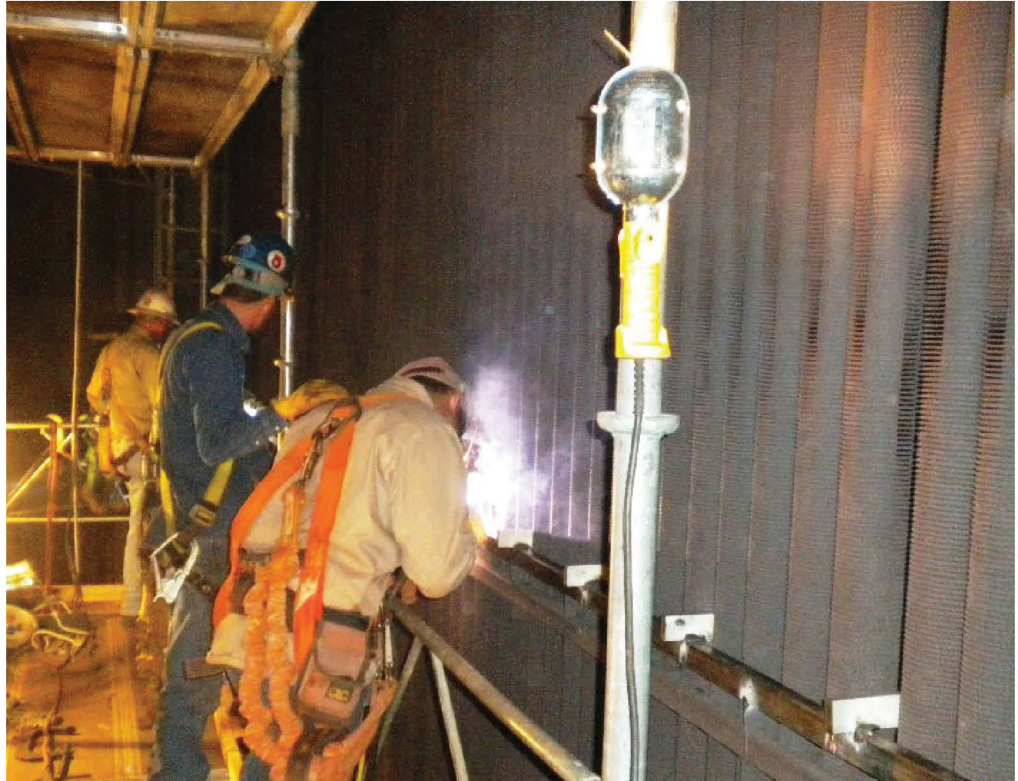
Following the modification of the Siemens 501G gas turbine diffuser tail cone section at a facility with a **Nooter/Eriksen** HRSG, a significant increase in vibration and noise coming from the HRSG was detected. The increase in vibration coincided with an increased movement of the reheater cross over piping at the main platform elevation. During a subsequent internal inspection of the first module by plant personnel it was noted that some of the tube fins had been damaged at the lowest (2) vibration supports. It was assumed that the turbine diffuser cone modification had increased the exhaust gas turbulence. The increased turbulence was suspected of causing the finned tubes to vibrate inside the vibration supports and wear away the fins. In addition the turbulence caused flexing of the first coil module which was evidenced by the movement of the cross over piping.

The alterations suggested for the HRSG were based on the successful modifications performed on a similar **Nooter/Eriksen** HRSG behind a Siemens 501G turbine. The other **Nooter/Eriksen** unit had operated successfully for over (3) years following the modifications as suggested by **Nooter/Eriksen**.
