Coil Replacement Project – August 2009 – Argentina

Coil Replacement Project – June 2010 – Argentina

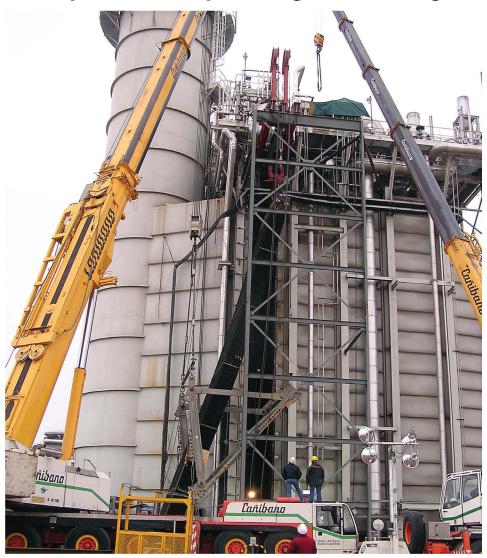
After approximately 10 years of service, a power producer with a **Nooter/Erikse**n HRSG had begun experiencing numerous failures in their LP Evaporator coils. The coils were originally fabricated using carbon steel tubes. This material combined with improper water chemistry led to the occurrence of Flow Accelerated Corrosion (FAC), the root cause of the failures. Temporary repairs were made by a local contractor which eventually caused additional failures and the need to replace the coils. **Nooter/Eriksen Aftermarket Services** designed and supplied new LP Evaporator coils utilizing T11 tubes to provide a design more resistant to FAC. **Nooter/Eriksen** also assisted the plant with recommendations for their water chemistry program to bring it in line with current standards and further reduce the probability of recurring FAC issues.

Special consideration was needed for the installation of the new LP Evaporators due to the coils being part of a larger bundle and spatial constraints on site. These problems were addressed by **Nooter/Eriksen** providing a detailed procedure to remove the old coils and install the new coils through the HRSG sidewall utilizing a trolley system. This allowed for the work to be completed in a brief outage with minimal alterations required to the overall plant. A **Nooter/Eriksen** Field Technical Advisor was present during the outage to aid with the procedure and to assist with any possible issues. The project was successfully completed in August 2009.

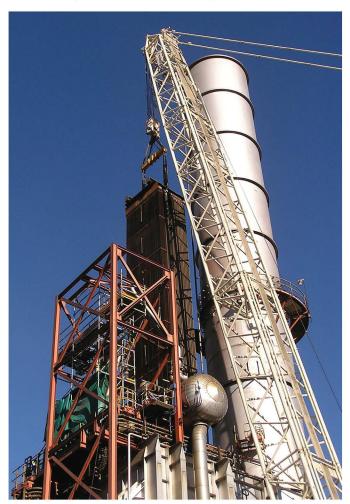
After operating for 10 years, a cogeneration plant with a single Nooter/Eriksen HRSG servicing a refinery had begun experiencing multiple tube leaks in their HP Economizer Coils. The cause of the leaks was determined to be underdeposit corrosion due to iron deposits. The feedwater quality could not be addressed directly as it is supplied by the refinery and is beyond the control of the HRSG operators.

As leaks continued to occur, the tubes had to be removed and plugged. The plugging reached a point where approximately 25 tubes had been removed and HP Economizer performance reduction was significant. The increased frequency of the leaks also led to forced outages

and reduced overall plant reliability. **Nooter/Eriksen Aftermarket Services** was contacted to design and supply replacement coils to address the ever growing issue. New HP Economizer coils utilizing Duplex stainless steel materials were designed and fabricated to better withstand the feedwater conditions.

The HP Economizer coils were supplied bundled with a portion of an HP Evaporator for ease of installation and reduced outage time. A detailed installation procedure was provided to minimize the amount of HRSG alterations that had to be made for the installation and also minimize the outage time. A **Nooter/Eriksen** Field Technical Advisor was sent to the job site during the outage to oversee the installation and assist with any challenges. The tight refinery layout created some unique challenges with spatial constraints and positioning of the cranes. **Nooter/Eriksen** further assisted the plant by reviewing their overall water chemistry and operation procedures to address their specific issues. The coils were successfully installed in June 2010.
